Technical Service Bulletin

INCORRECT ROTATION CAN LEAD TO SYSTEM FAILURE ON HOLDEN 1.6, 1.8, 2.0, 2.2 16V ENGINES

Gates Timing Belt Part Numbers: T305, T309, T1057, T1064, T1094 & T1566

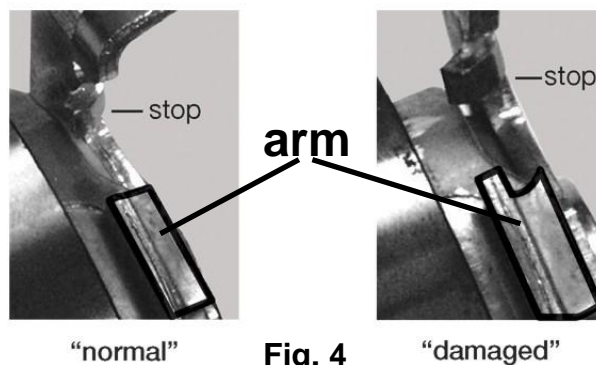
Fig. 4

Rotating the tensioner in the wrong direction, having the allen keyhole in the wrong position to start off, not turning the engine 2 revolutions before and after setting the tension, can lead to system failure. This will cause the arm of the tensioner to hit the stop, creating a hammering noise, damaging and possibly even rupturing that part. This failure mode is very common and can easily be recognised when inspecting the edge of the arm (Fig. 4). The resulting wrong tension can cause the belt to rupture.
