TECH NOTE

AUTOMOTIVE – PASSENGER CAR INCORRECT ROTATION CAN LEAD TO SYSTEM FAILURE ON HOLDEN 1.6, 1.8, 2.0, 2.2 16V ENGINES

BULLETIN: TSB001_AU

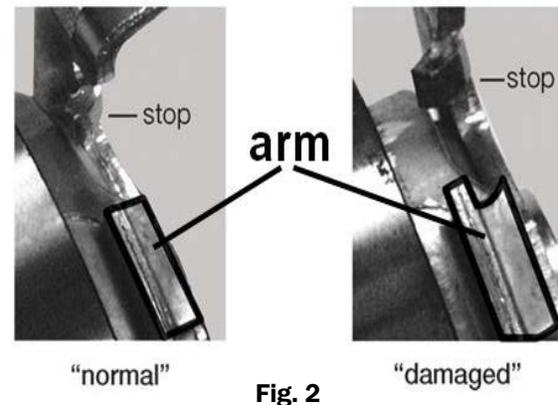
Fig. 2

Rotating the tensioner in the wrong direction, having the allen keyhole in the wrong position to start off, not turning the engine 2 revolutions before and after setting the tension, can lead to system failure. This will cause the arm of the tensioner to hit the stop, creating a hammering noise, damaging and possibly even rupturing that part. This failure mode is very common and can easily be recognised when inspecting the edge of the arm (Fig. 4). The resulting wrong tension can cause the belt to rupture.
