Technical Service Bulletin

LOOSENING THE WATER PUMP BEFORE BELT INSTALLATION IS VITAL TO CORRECT TENSION ON HOLDEN & DAEWOO 16V PETROL ENGINES

Holden/Daewoo
Cielo, Espero, Kalos, Lacetti, Lanos, Nubira,
1.4 16V, 1.5 16V, 1.6 16V
Various engine codes

Gates Timing Belt & Component Kit Part Numbers: T310, TCK310, TCKWP310

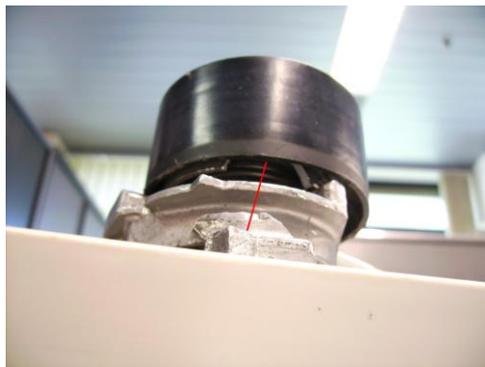
Fig. 2

If the tensioner bolt is not loosened, the pointer of the tensioner will hit the cold stop violently. This could seriously damage the pointer, resulting in a rupture (later on). Proceeding this way, in order to be able to install the new belt, the pointer of the tensioner has to be pushed back. When trying this with a screwdriver, you risk that the screwdriver will slip off the pointer (because of the high spring tension) which will again hit the cold stop. Fig. 3 shows where the pointer is situated on a good tensioner (in its rest position).

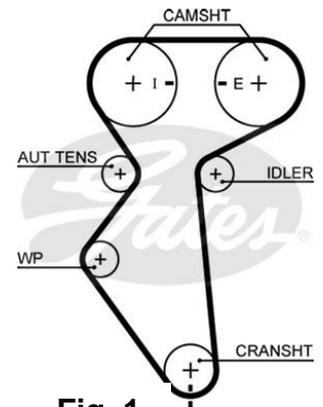
Fig. 1

Drive failure is mainly caused by not rotating the water pump to set the belt tension. Although the drive is equipped with an 'automatic' tensioner, this still has to be set up correctly. And this requires manipulation of the unconventional water pump, located just below the tensioner. (Fig. 1)

Some mechanics hesitate to loosen the water pump, as they are concerned about water leaks, or do not have the proper tool to rotate the water pump. However, in this case, loosening the water pump is vital in order to reach the correct installation tension. (A new O-ring may be needed)

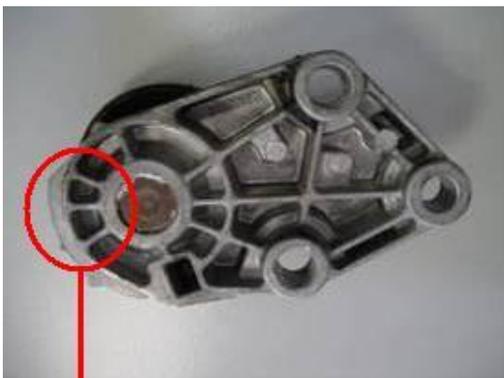
Counterfeit
Fig. 12

In addition, watch out for counterfeit tensioners which can be widespread in certain markets (Fig.10 and 11 are OE, Fig. 12 is counterfeit)
