## Technical Service Bulletin

### HONDA ACCORD/LEGEND/MDX TIMING COVER MODIFICATION REQUIRED WITH REPLACEMENT OF BELT TENSIONER

Make: Honda  
Model: Accord, Legend, MDX  
Engine: 3.0L, 3.5L & 3.7L  
Year: 2003 - On

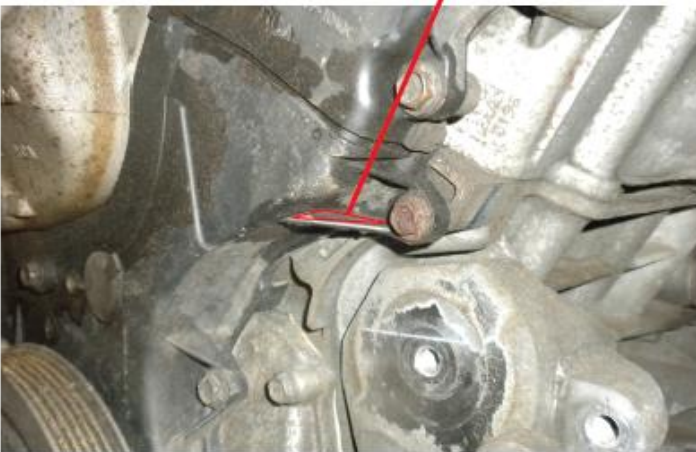
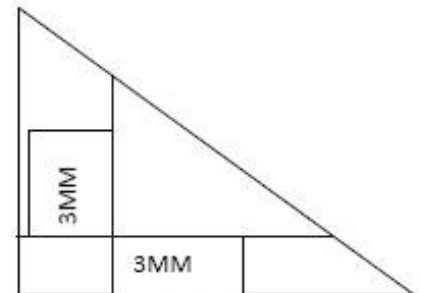
Improper clearance may result in a damaged front timing belt cover.

**THIS AREA WILL NEED TO HAVE 3MM OF MATERIAL REMOVED**

**IMPROPER INSTALLATION MAY RESULT IN A DAMAGED FRONT TIMING BELT COVER AND IMPROPER ACCESSORY BELT TRACKING, EVENTUALLY LEADING TO BELT FAILURE!**

The removal of approximately 3mm of plastic material from the lower timing belt cover is recommended prior to the installation of the updated accessory belt drive tensioner, allowing for proper clearance
