## AUTOMOTIVE – PASSENGER CAR

# HONDA ACCORD/LEGEND/MDX TIMING COVER MODIFICATION REQUIRED WITH REPLACEMENT OF BELT TENSIONER

**BULLETIN:** TSB005\_AU

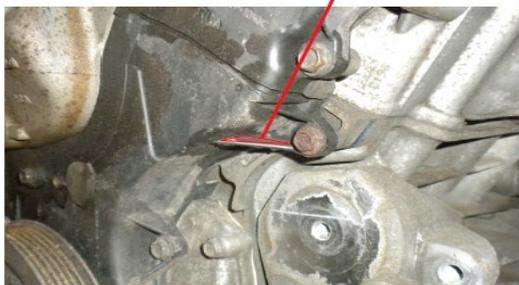
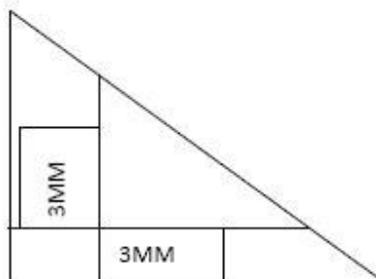
Improper clearance may result in a damaged front timing belt cover.

THIS AREA WILL NEED TO HAVE 3MM OF MATERIAL REMOVED

The removal of approximately 3mm of plastic material from the lower timing belt cover is recommended prior to the installation of the updated accessory belt drive tensioner, allowing for proper clearance.
