## TECH NOTE

# AVOIDING 'SPONGE STATE' IN HYDRAULIC TENSIONERS

**BULLETIN:** TSB006\_AU

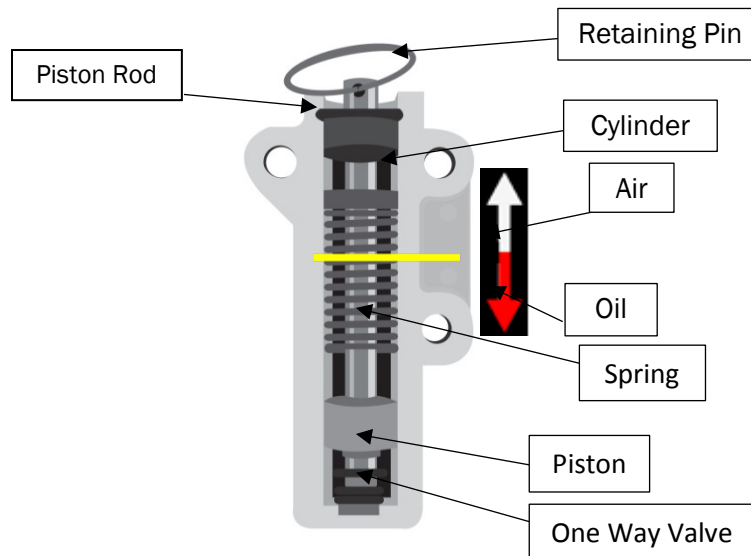
The piston should be solid and require considerable force to move, this can be checked by pressing the piston against a firm object. If there is any movement, the unit will require a bleed out procedure. If the bleed out procedure is not followed, premature failure will most likely occur.

**If there is movement in the tensioner, follow the bleed out procedure**

1. Set the actuator/tensioner with the piston rod in the extended position to a vertical press, and then slowly compress the piston rod to the bottom end, then slowly extend. Repeat this step 2 to 3 times (each cycle should take no less than a minute to avoid damage).
2. Compress the rod slowly, and then align the set hole of the rod with the set hole of the auto tensioner body and insert the retaining pin.
3. Install the auto tensioner in position. Leave the wire or pin installed.
4. Follow the vehicle manufacturer's specific installation procedures to ensure problem free operation.
5. If there is still movement in the piston rod, repeat this procedure.
