## TECH NOTE

# INSTALLATION RECOMMENDATIONS FOR TIMING BELT SYSTEM ON HONDA 1.7L ENGINES

**BULLETIN:** TSB008\_AU

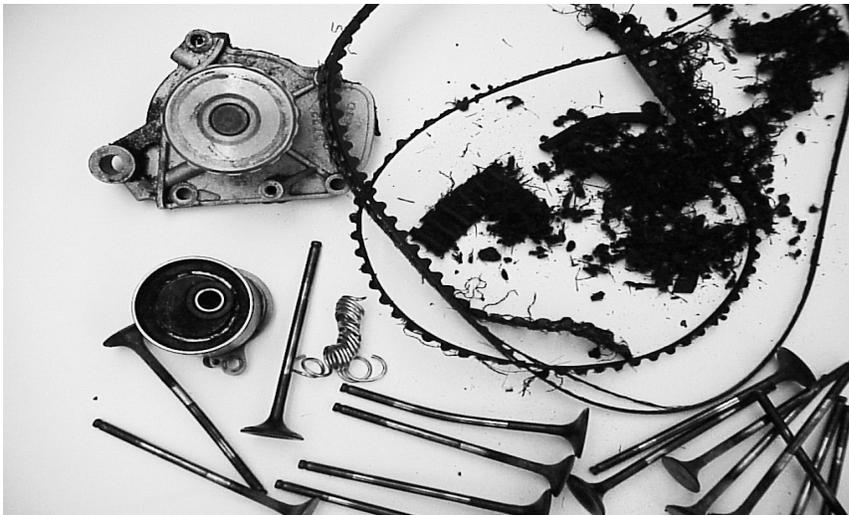
Below is the result from improper belt setup. Notice the damaged spring, this is the result of turning the crankshaft clockwise during initial setup, which is incorrect.

Crankshaft must be rotated two turns **COUNTERCLOCKWISE** with locking pin in tensioner and attachment bolt loose. Not following proper installation procedures will cause:

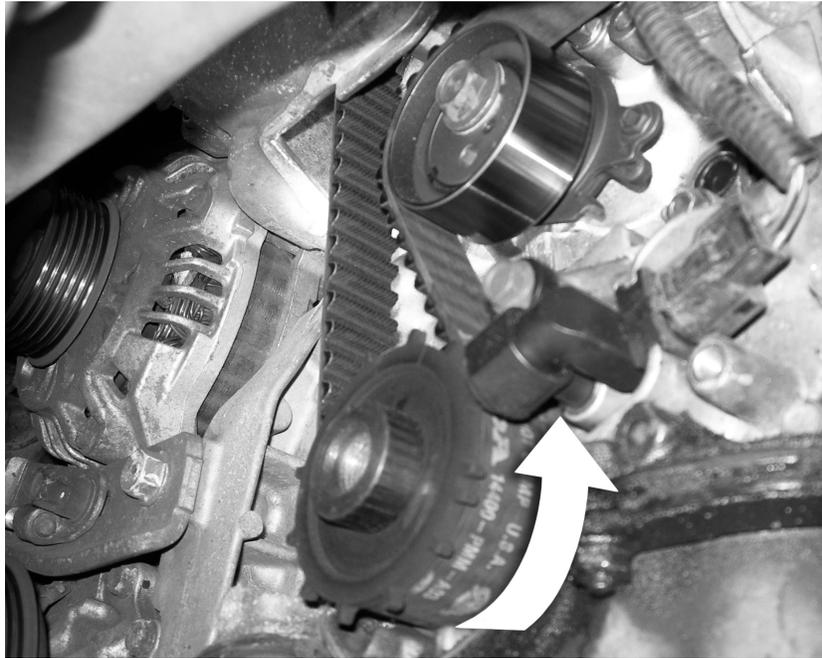
During setup attention needs to be given to the relationship of tensioner spring. The spring must be in the “UP” position which is noted on the spring rubber dampener.
