Technical Service Bulletin

Timing Belt Tracking Issues on Renault Engines

Failure Mode: Timing Belt tracking issues.

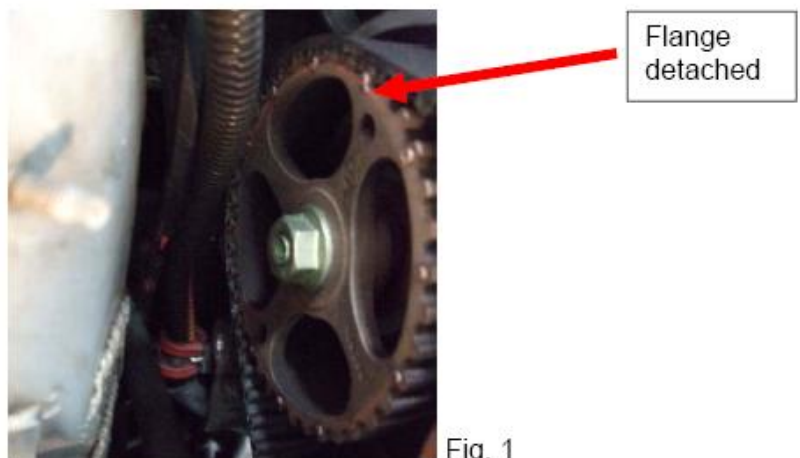
Fig. 1

The timing belt tracks heavily toward the front of the engine which can cause the camshaft pulley flanges to detach and possibly enter the drive system (Fig. 1 shows a detached camshaft flange). This can result in timing system damage and complete timing belt failure.

This failure mode originates from excessive movement of a worn or faulty water pump bearing.

To prevent this failure, it is recommended that the water pump is replaced at the same time as the timing belt, even if the Water Pump is not showing visible signs of fatigue.

In the event of the camshaft pulley becoming loose or detached, Gates recommends that an OEM replacement is sourced.

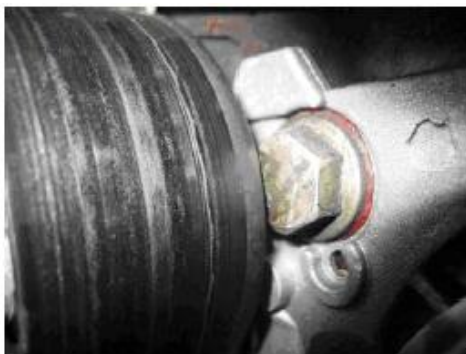
Fig.2

The correct bolt and correct clearance are critical items for this application and will cause issues if not correctly applied.

Fig. 2 shows the extremely limited space between the water pump bolt and tensioner pulley.

There is very little room for error here.

1. While changing the water pump, ensure the original correct OEM bolts/washers are reused and torqued correctly to ensure clearance between the pulley and bolt head is maintained.

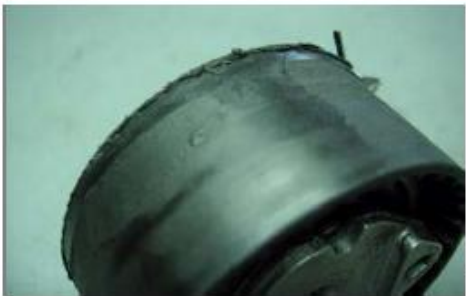
Fig. 3 shows the result of pulley contact due to an incorrect aftermarket bolt being installed or a bolt coming loose.

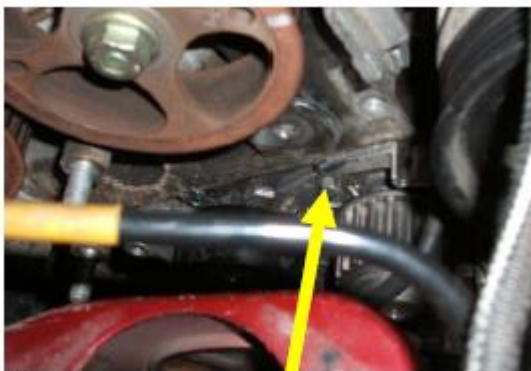
Fig. 4

2. When installing the new timing idler pulley, ensure that the spacer (sitting between the old pulley and the engine block) is re-fitted between the new pulley and the engine block. If not, the idler pulley can touch the water pump, causing idler and belt failure (Fig. 4 and 5).

Rubbing mark

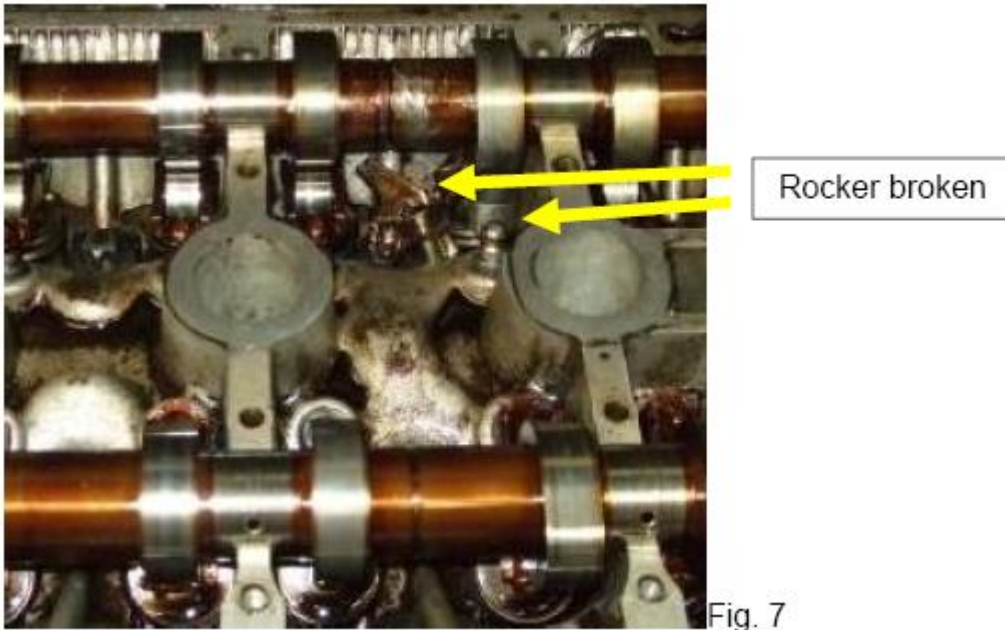
If timing system failure and piston to valve contact has occurred, close inspection of the camshaft rocker assembly is essential. Breakage of the rocker arms is possible and replacement is necessary, Fig. 7 shows a broken rocker.
