Technical Service Bulletin

AUTOMOTIVE <> PASSENGER CAR SYNCHRONOUS BELT DRIVE SYSTEM

BULLETIN #TSB_017_AU

CAUTION REQUIRED TO CORRECTLY INSTALL THE TENSIONER ASSEMBLY AND AVOID PREMATURE FAILURE

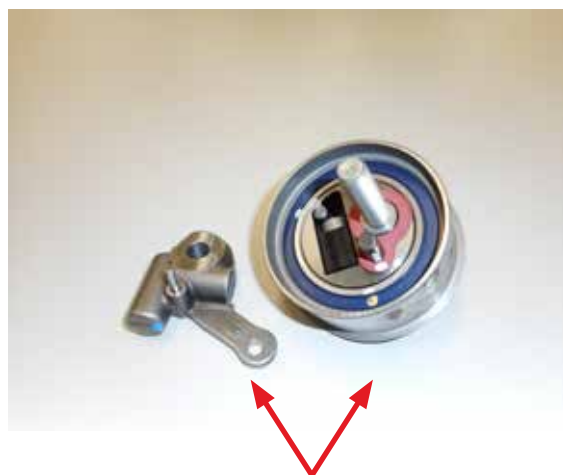
- **DO NOT remove the pin before installation.** Removing the pin before it's required will cause the hydraulic actuator to separate or partially separate from the pulley. This will cause the piston of the actuator to either completely exit the hydraulic chamber or fully extend to the end of its stroke suddenly.

- **Do not use** if hydraulic actuator has become separated from the tensioner pulley. There is an internal spring that will also need to be repositioned which can lead to premature failure if not done precisely.

This can occur from dropping or fumbling the unit during installation. **Keeping the rubber sleeve over the bolt threads until the very moment that the tensioner is to be installed** can help in preventing the hydraulic mechanism from separating from the tensioner pulley.

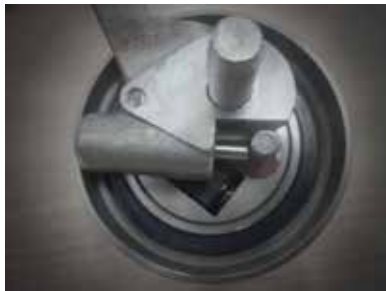
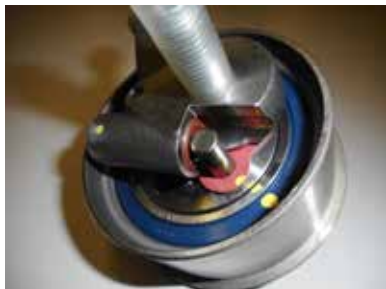
This is the correct state of the tensioner before installation.

DO NOT install if the tensioner assembly does not resemble the image above.
