AUTOMOTIVE – PASSENGER CAR

BULLETIN: TSB002_AU

CORRECT TIMING BELT CLEARANCE IS CRITICAL ON 2.0/2.5L MAUNUAL APPLICATIONS

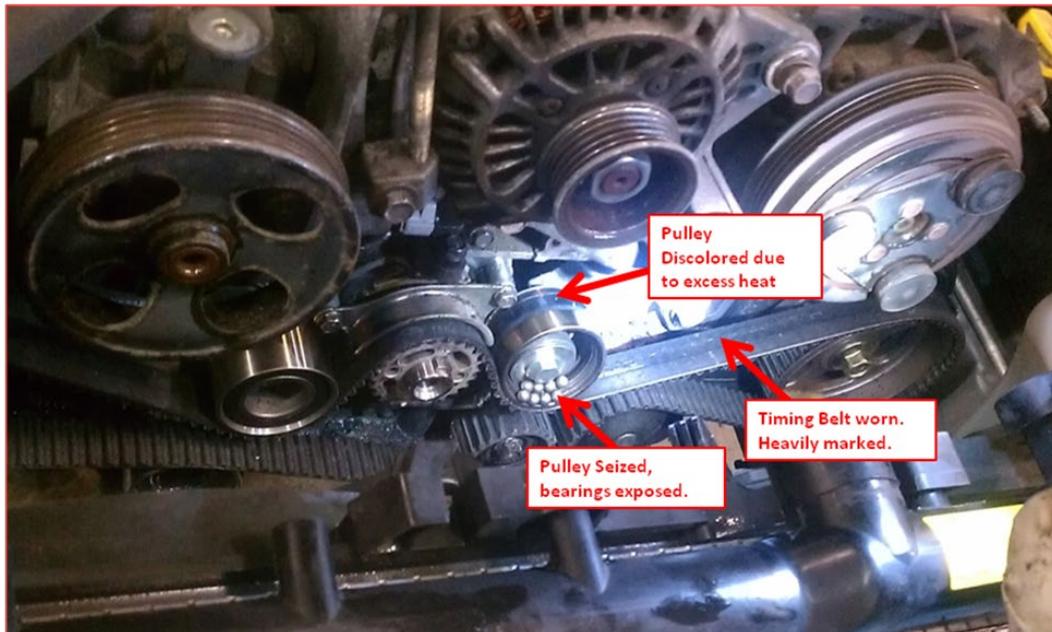
Fig. 1

There is a growing number of timing belt and component failures on popular engines. More specifically, the nature of the failure indicates an exposure of the tensioner unit and idlers to extreme heat. In some cases, the heat is so severe that it has melted the top cover of the timing belt. This extreme heat results in the failure of the automatic tensioner, influences the timing belt to 'jump teeth', and ultimately causes serious engine damage. Gates Australia has seen cases where the heat generated has been so severe that the bearings have disintegrated with the vehicle having travelled less the 50 kilometres.

The diagram below (Fig. 1) shows a typical result of the excessive heat generated from this issue:

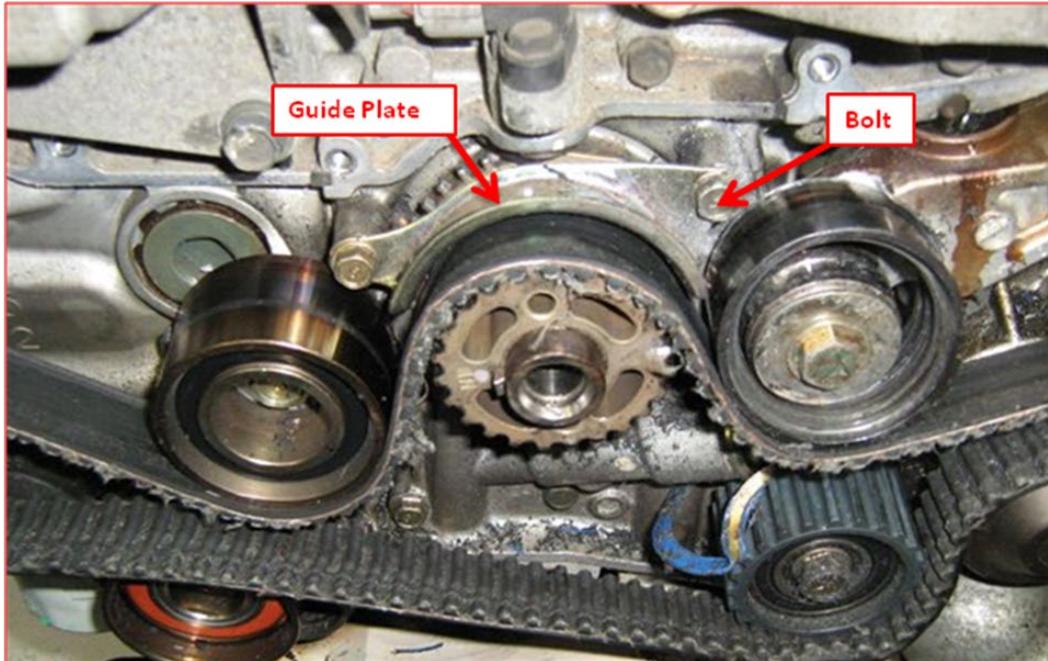
Having said this, upon installation, the rotation of the bolts which secure the guide plate to the engine naturally forces the guide plate down towards the belt (see Fig. 2 below). If the guide plate is installed too close to the belt or if the bolts on the guide plate aren't tightened correctly, the plate can make contact with the timing belt cover. Any contact between the guide plate and belt, and/or an incorrect clearance between the timing belt and guide plate, will cause friction and generate excessive heat. This extreme heat will compromise the bearing's lubricant and lead to bearing seizure/failure.

- Upon installation, the guide plate must have a clearance of 1mm +/- 0.5mm to the belt.
- Having said this, the mounting holes on the guide plate are larger than the bolt which fastens it, and this effectively makes the plate position adjustable. As the bolts are tightened to secure the plate, the rotation of the bolt naturally pushes the plate down towards the belt.

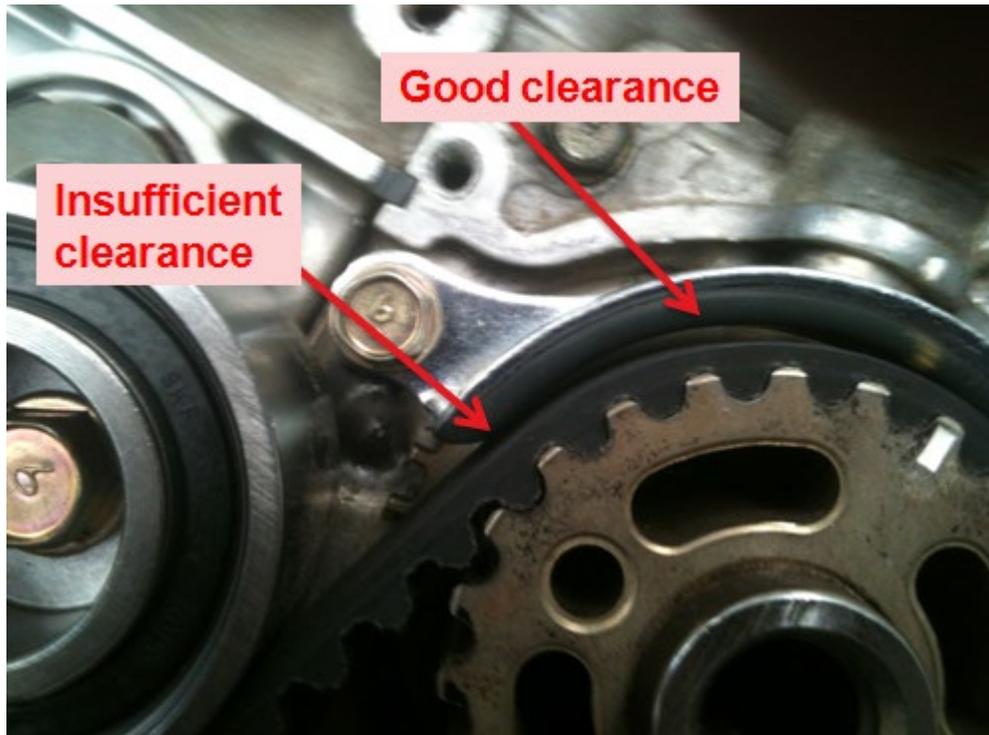
Fig. 3

- This is why the failure mode is becoming more prevalent.
- Also, clearance distance needs to be consistent across the full arc of the plate.
- As such, while there may be adequate clearance in one section of the guide plate, a fitter **MUST** ensure that the same applies to the other section. As pictured, the top of the guide has clearance however the left side doesn't (Fig 3.).

- This is a very common problem.

Unless special care is taken to ensure that the correct clearance is achieved between the timing belt and guide plate, this failure mode will occur. In addition to this, the correct clearance needs to be achieved consistently across the FULL arc of the guide plate.
