Fleet and Heavy Duty TECHTIPS

Early belt failure could indicate pulley incompatibility

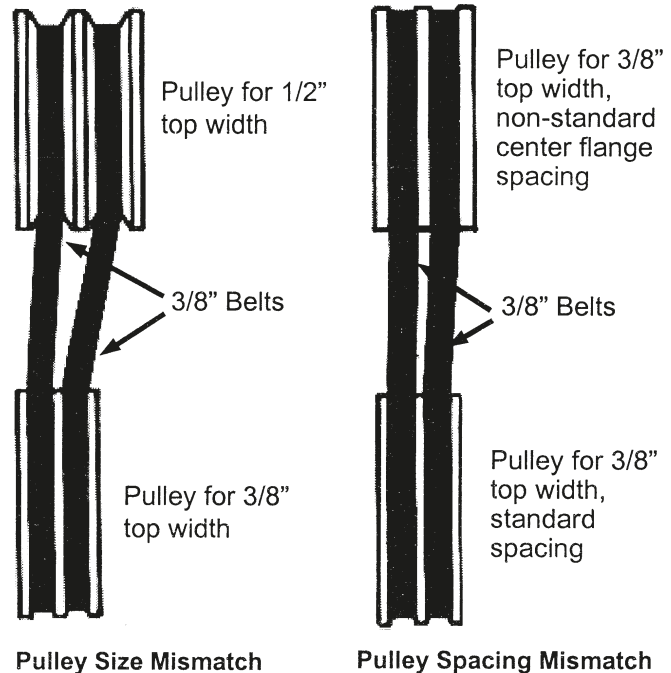
Figure 1

Pulley size mismatch (Fig. 1) often occurs when an original component — an alternator, for example — is replaced in a vehicle. The new alternator may come with a pulley attached or a new pulley may be used to replace the old one. If the new pulley has a different sized top-width (a 1/2" replacing a 3/8", for instance), pulley size mismatch will occur.

In this case, because of the size mismatch, the belt will not seat properly in the drive. The result is excessive wear, belt squeal, belt turnover and premature failure.

Obviously, frequent replacement of belts is not the solution to the problem. When installing a new component, or when replacing a belt after what seems to be an early demise, take time to assure pulley compatibility.

Should a pulley be out of size or spacing with the rest of the pulley and belt system, the proper pulley should be installed for the performance of the system.

Belts can take on early failure through pulley spacing mismatch (Fig. 2) as well.

Pulley spacing mismatch can occur in the construction of the vehicle. A fire truck may have a chassis manufactured by Freightliner, an engine

made by Detroit Diesel and the vehicle designer decides to incorporate an extra heavy-duty alternator and not consider a possible pulley mismatch which could result.

Dual-groove pulleys incorporate a ridge between grooves to separate the belts. The specifications set by the Rubber Manufacturers' Association, for example, call for a spacing of 16.5 mm. Other manufacturers may specify wider spacing.

To the untrained eye, two 3/8ths-inch belts can be installed side by side on seemingly compatible pulleys, but until a belt fails prematurely or flips out of the drive, the incompatibility might not be seen.

Using single belts in dual-groove drives doubles the potential for belt turnover or failure. Using a joined V-belt, such as Gates Green Stripe®
