Fleet and Heavy Duty TECHTIPS

Selecting the best belt tensioner

Will Misalignment Decrease Service Life?

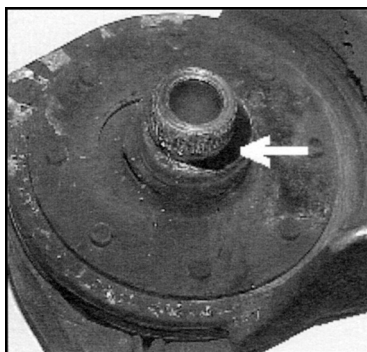
Gates Corporation engineers say misalignment results from excessive wear at the point where the tensioner arm bushing rotates inside the base pivot, or spring housing, bushing. The hollow base pivot bushing enlarges so that it no longer fits snugly on to the tensioner arm bushing. This wear eventually leads to tensioner vibration, misalignment, and more frequent replacement of the belt and other accessory drive components.

The flat spring tensioner system is more susceptible to wear for several reasons.

First, its construction consists of a steel tensioner arm bushing and an aluminum base pivot bushing. The two dissimilar

metals create friction and wear as the tensioner arm oscillates.

Second, because of the manufacturing methods, the pivot bushing may not mate properly. When there is excessive "play" between the two bearing surfaces, wear accelerates.

Improper wear of the bearing shafts of a flat spring tensioner creates gaps (arrow) that increase vibration and reduce service life.

Gates DriveAlign tensioners feature the round spring system to reduce component wear and increase the service life of the entire accessory belt drive system.
