Fleet and Heavy Duty TECHTIPS

Troubleshooting V-ribbed belt noise

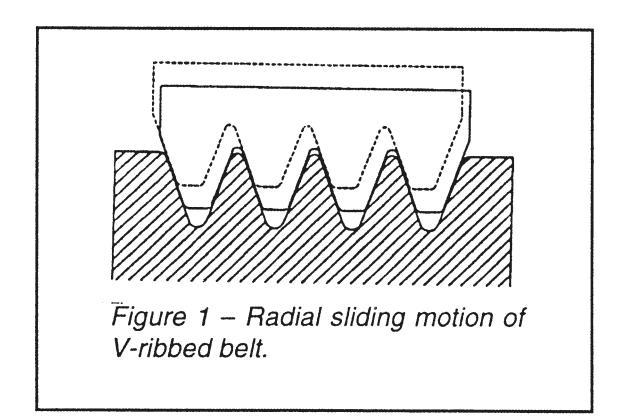
Intermittent belt chirp that increases in frequency as the engine is revved up can be the result of belt vibration caused by misaligned drive pulleys - a leading cause of belt noise. As a misaligned V-ribbed belt span enters the grooves of a pulley, initial contact is made with only one side of the V-groove. The greater the misalignment angle, the greater the radial sliding length experienced by the belt ribs as the belt seats in the pulley causing frictional vibrations, or chirping (see Figure 1).

In the case of severe misalignment, repositioning of drive components using shims, or by changing the press fit of the pulley or the shaft, may be required. Pulley alignment and tension must be correct on all V-ribbed belt applications for the drive to operate properly.
