TECH NOTE

BULLETIN: TSB_027_AU

FOLLOWING THE OEM INSTALLATION PROCEDURE CORRECTLY IS CRITICAL ON 4D56 DOHC ENGINES

- 2.5L Diesel (4D56 DOHC)

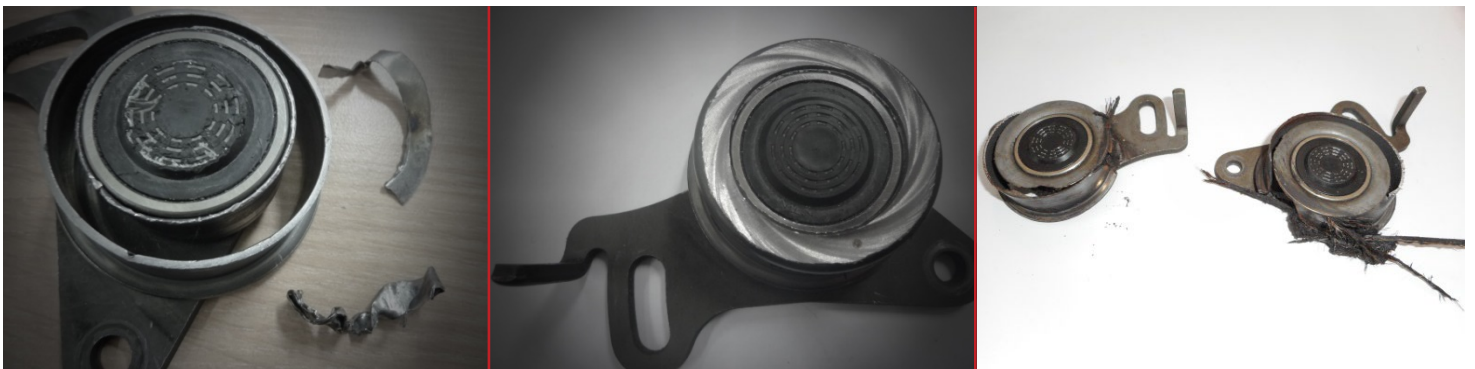
- Camshaft assembly bolt braking.
- Balance shaft tensioner failure.
- Timing belt jumping teeth.
- Balance shaft belt shredding and interfering with the camshaft belt.

Images of failed balance shaft tensioner pulleys due to incorrect installation:

- Never turn the crankshaft anti-clockwise
- When installing the balance shaft tensioner spring ensure the shorter end is facing toward the water pump
- When the balance shaft belt is fitted ensure that the tension side is not slack
- Tighten the hexagon socket head bolt first (Fig. 1 Bolt (B): 20nm) then tighten the tensioner assembly mounting flange bolt (Fig 1. Bolt (A): 23nm)
- Observe correct tightening sequence, otherwise belt tension will not be correct
- Incorrect belt tension can result in the tensioner spring making contact with the belt and/or tensioner pulley
