Technical Service Bulletin

CORRECT TIMING BELT CLEARANCE IS CRITICAL ON SUBARU APPLICATIONS

Gates Timing Belt Part Numbers: T172, T254, T277, T277R, T304 & T304R

Subaru's 2.0L/2.5L, SOHC/DOHC, Manual transmission engines:

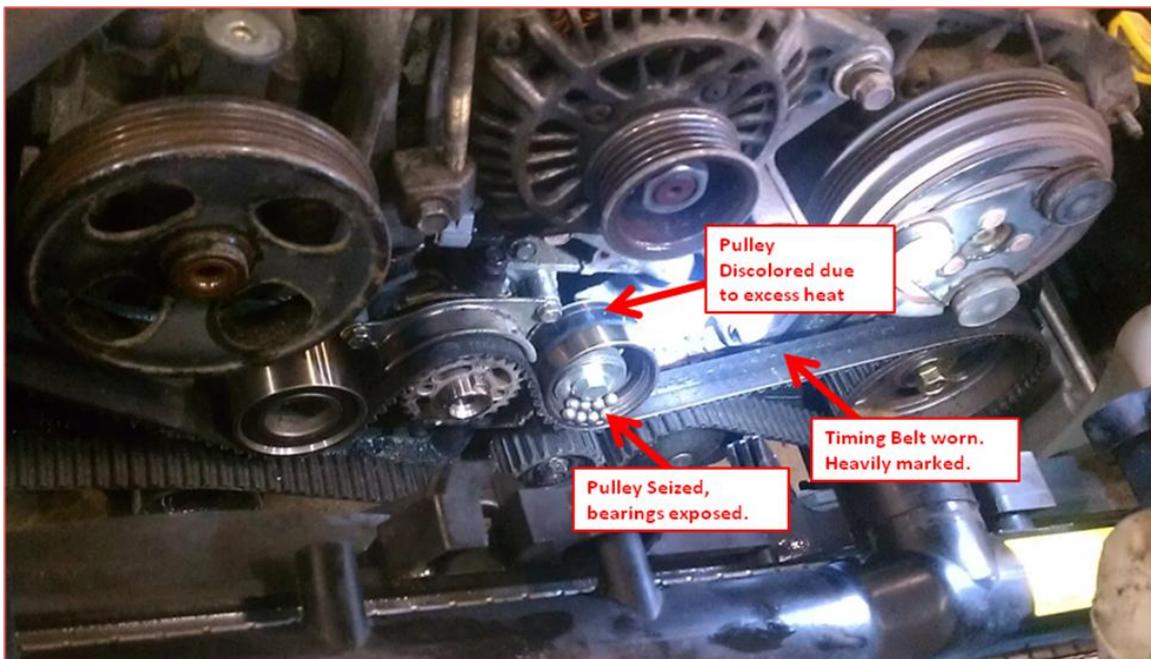
Fig. 1

There is a growing number of timing belt and component failures on popular Subaru engines. More specifically, the nature of the failure indicates an exposure of the tensioner unit and idlers to extreme heat. In some cases, the heat is so severe that it has melted the top cover of the timing belt. This extreme heat results in the failure of the automatic tensioner, influences the timing belt to 'jump teeth', and ultimately causes serious engine damage. Gates Australia has seen cases where the heat generated has been so severe that the bearings have disintegrated with the vehicle having travelled less the 50 kilometres. The diagram below (Fig. 1) shows a typical result of the excessive heat generated from this issue:

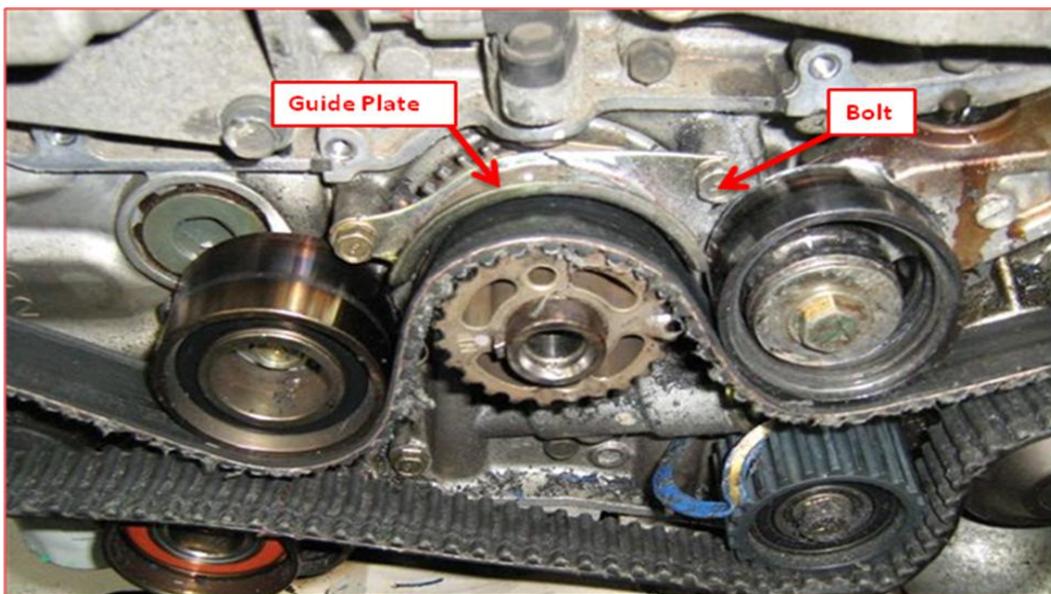
Having said this, upon installation, the rotation of the bolts which secure the guide plate to the engine naturally forces the guide plate down towards the belt (see Fig. 2 below). If the guide plate is installed too close to the belt or if the bolts on the guide plate aren't tightened correctly, the plate can make contact with the timing belt cover. Any contact between the guide plate and belt, and/or an incorrect clearance between the timing belt and guide plate, will cause friction and generate excessive heat. This extreme heat will compromise the bearing's lubricant and lead to bearing seizure/failure.

- Subaru state that upon installation, the guide plate must have a clearance of 1mm +/- 0.5mm to the belt.
- Having said this, the mounting holes on the guide plate are larger than the bolt which fastens it, and this effectively makes the plate position adjustable. As the bolts are tightened to secure the plate, the rotation of the bolt naturally pushes the plate down towards the belt.

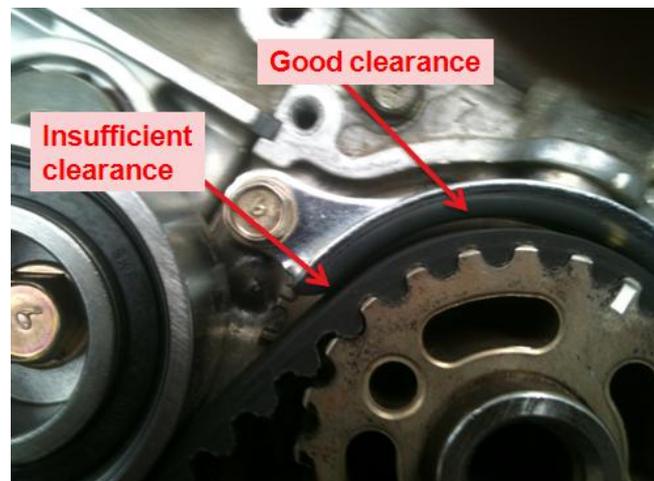
Fig. 3

- This is why the failure mode is becoming more prevalent.
- Also, clearance distance needs to be consistent across the full arc of the plate.
- As such, while there may be adequate clearance in one section of the guide plate, a fitter MUST ensure that the same applies to the other section. As pictured, the top of the guide has clearance however the left side doesn't (Fig 3.).

- This is a very common problem.

Unless special care is taken to ensure that the correct clearance is achieved between the timing belt and guide plate, this failure mode will occur. In addition to this, the correct clearance needs to be achieved consistently across the FULL arc of the guide plate.

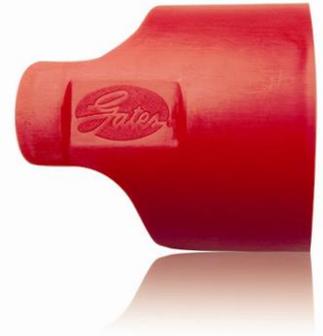
Fig. 4

Given the complexity and the limited space in the engine bay of this vehicle, it is extremely difficult to achieve the correct clearance through visual inspection (unless the engine is removed from the vehicle). As such, Gates has created an innovative, new and specifically designed gauge to help automotive technicians achieve the correct clearances required. This gauge is called 'The Gates Timing Belt Spacer Tool' (Fig 4.).

The final step of replacing the timing belt is to mount the guide plate. After loosely tightening the guide plate bolts the Gates Spacer Tool is inserted between the belt and the plate. The bolts are then firmly tightened with the tool still in place. The tool is then removed leaving an ideal clearance between the plate and the belt.

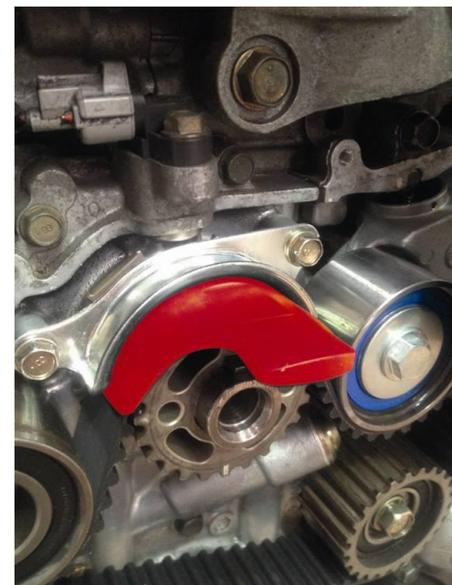
Fig. 5

The Gates Spacer Tool is Australian Design Registered with a Patent Pending, and is specifically designed to assist the automotive technician achieve correct and even clearance between the timing belt and guide plate in the affected Subaru applications (Fig. 5). Further, the tool is accurate, safe and easy to remove upon completion of the job.
