Coolant Hose Fails From The Inside

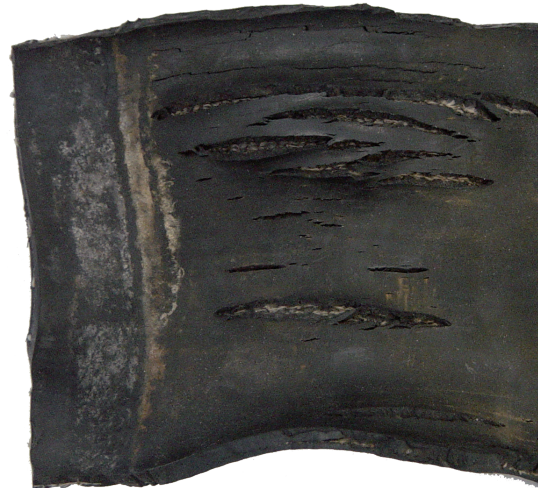
An example of coolant hose failure caused by ECD.

The best way to check a coolant hose for the effects of ECD is to squeeze the hose near the clamps or connectors. Check for any difference in the feel between the middle and ends of the hose. If the ends are soft and feel mushy, chances are the hose is under attack by ECD. To avoid breakdowns, the hose should be replaced immediately with an ECD-resistant hose. Also, if it's been four years since the last time the coolant hoses were changed, they should be replaced.

To address the damage caused by ECD, Gates developed an electrochemically-resistant coolant hose using a patented EPDM (ethylene propylene rubber) formulation and special wrapped reinforcement. These hoses are long-lasting with no ECD effect. In addition to providing electrochemical resistance, the new EPDM hose offers improved performance characteristics over both standard rubber hose and much more expensive silicone hose.

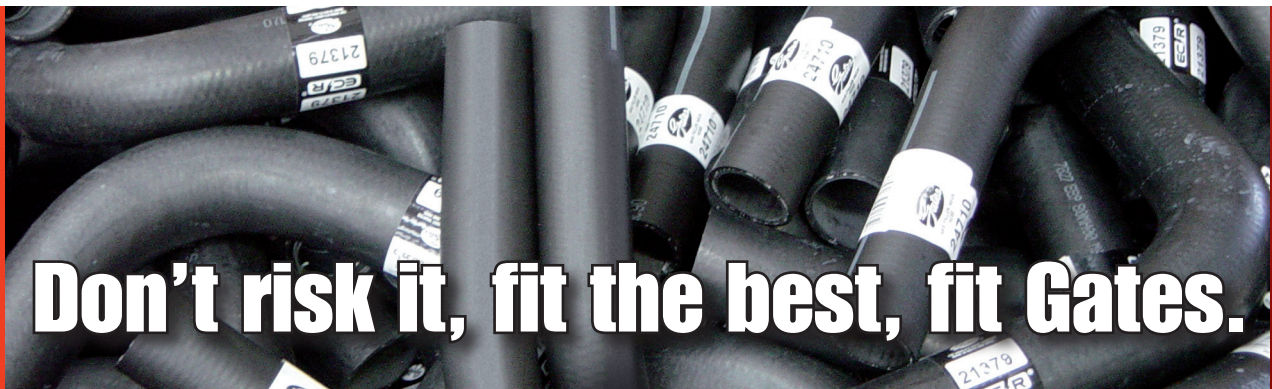
The phenomenon is known as electrochemical degradation, or ECD. It occurs because the hose, liquid coolant and the engine/radiator fittings form a galvanic cell or "battery". This chemical reaction causes micro-cracks in the hose tube, allowing the coolant to attack and weaken the hose reinforcement. Failure results from a pinhole leak or a burst hose.
