COOLANT HOSE PACK

TAKE THE HASSLE OUT OF SHOPPING AROUND FOR COOLANT HOSE PARTS.

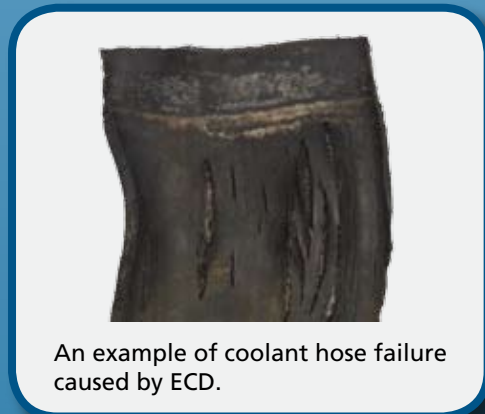
An example of coolant hose failure caused by ECD.

The primary cause of coolant hose failure is an electrochemical attack on the rubber compound in the hose.

This phenomenon is known as electrochemical degradation, or ECD. It occurs because the hose, liquid coolant and engine/radiator fittings form a galvanic cell or "battery". This creates a chemical reaction which causes micro-cracks to form in the hose tube.

Coolant seeps into these cracks or stryations and begins to break down the reinforcement. This leads to hose failure and ultimately roadside breakdowns.

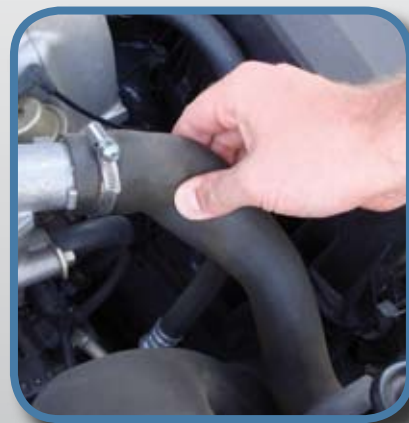
1. Make sure the engine is cool.
2. Use fingers and thumb to check for weakness.
3. Squeeze near the clamps and connectors. ECD occurs within two inches of the ends of the hose - not in the middle (See image for correct position).
4. Check for any difference in the feel between the middle and ends of the hose. "Gaps," or "channels," can be felt along the length of the hose where it has been weakened by ECD. If the ends are soft and feel mushy, chances are, the hose is under attack by ECD.

The best way to check coolant hose for the effects of ECD is to squeeze the hose near the clamps or connectors using the following procedure:

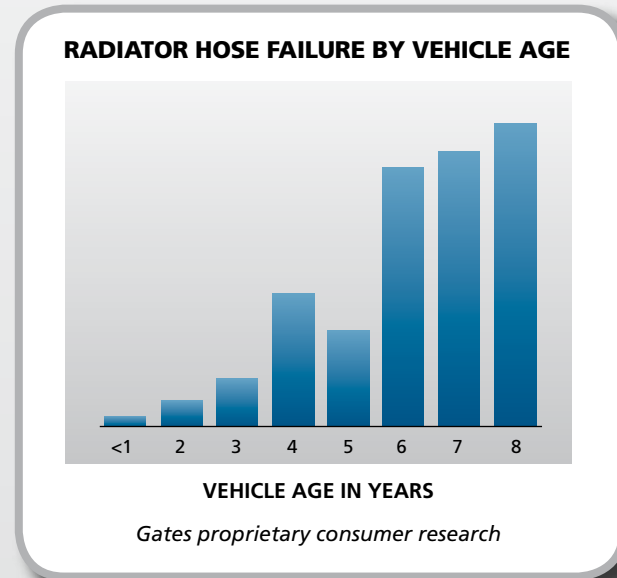
Pay special attention to hoses that have been in operation for four or more years. Hose failures increase dramatically after that period (see chart).

The best advice is to suggest replacement every four years for most vehicles. Vehicles operating under severe conditions may require more frequent replacements.
