SYNCHRONOUS BELT FAILURE ANALYSIS GUIDE

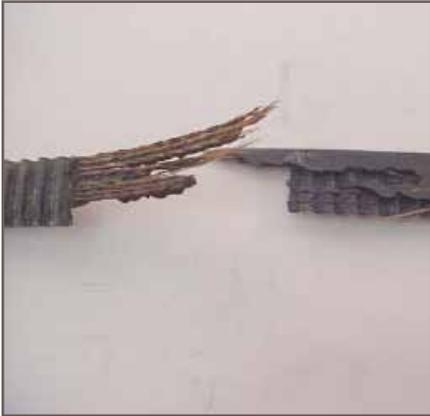
A failure that occurs when a belt reaches its ultimate tensile cord fatigue life, after running for a period of two to three years may be considered to be normal. Belt tensile failure due to cord fatigue after a long running period is considered to be ideal. Figure 1 illustrates a jagged 45-degree belt fracture that is typical of tensile cord at the end of its fatigue life.

Figure 1 – Normal fatigue failure

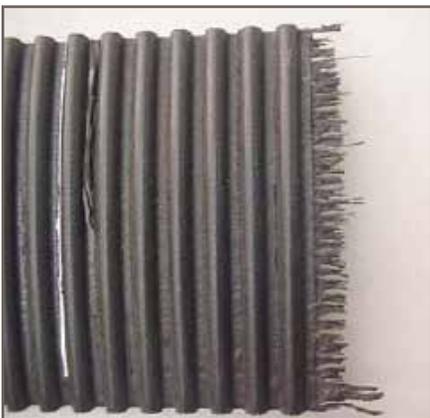
A “crimp” type belt failure often resembles a straight tensile failure as illustrated in Figure 3. A straight type of break like this may occur when belt tensile cords are bent around an excessively small diameter. A sharp bend may result in large compressive forces within the tensile members causing individual fibers to buckle or crimp, reducing the overall ultimate tensile strength of the belt. Belt crimping damage is most commonly associated with belt mishandling, inadequate belt installation tension, sub-minimal sprocket diameters, and/or entry of foreign objects within the belt drive.

Figure 3 – Crimp failure

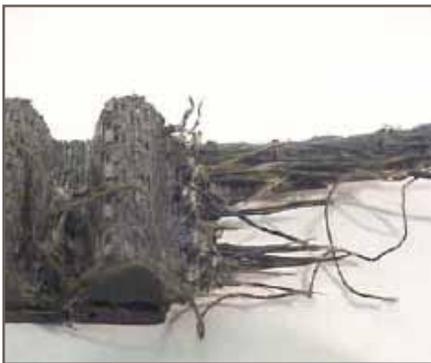
Severe shock loads can result in belt tensile breaks with a ragged and uneven appearance as illustrated in Figure 4. The particular belt teeth engaged in the sprocket at the instant of the shock load may also develop root cracks and/or exhibit tooth shear. If the shock load occurred only once, or was cyclical and repetitious at one specific location around the belt, the remaining belt teeth may appear normal. Figure 5 illustrates how root cracks caused by shock loading can propagate through the teeth. Cracks forming at the tooth roots sometimes move towards the tooth tips. Teeth containing multiple cracks may then shear, leaving only a portion of the tooth behind.

Figure 4 – Typical shock load failure

The shock loads generated by the driven equipment may be an inherent part of system operation or may result from an occasional harsh condition such as jamming. If the drive shock loads cannot be eliminated, the belt tensile strength may need to be increased or the synchronous belt drive replaced with a more forgiving V-belt drive system capable of intermittent slip.

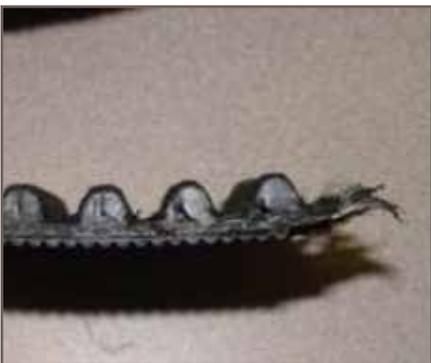
Figure 5 – Tooth root crack propagation

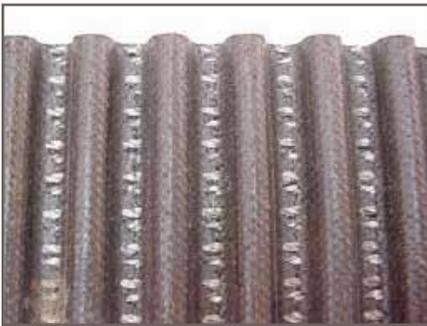
Figure 7 - Excessive land area wear

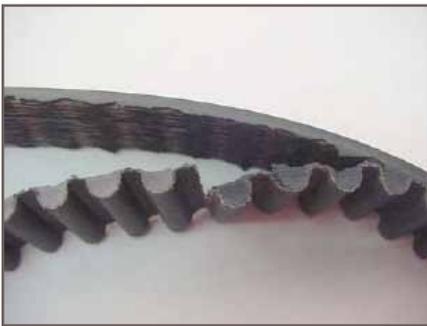
Figure 8 – Tooth separation failure

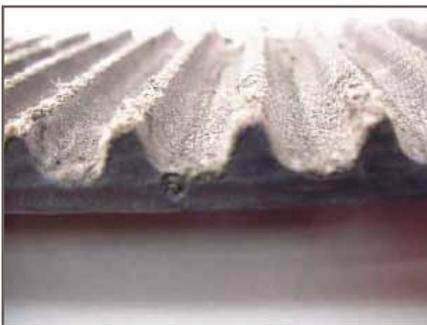
Figure 9 – Excessive tooth wear

As belt teeth climb out of their respective sprocket grooves to self tension, belt ratcheting or tooth jumping may occur before rubber tearing and belt tooth separation occurs. Belt tensile cord damage resulting from ratcheting can cause premature belt tensile failures. These tensile failures may resemble crimp type breaks (straight and clean) as well as shock load type breaks (jagged and angled). If belt ratcheting does not occur and belts continue to operate while self tensioning, excessive belt tooth wear often occurs. This tooth wear is referred to as “hook wear” and results from improper belt tooth meshing with the sprockets, as shown in Figure 9. Hook wear type belt failures result from

Increasing belt installation tension levels generally prevents premature belt failures due to tooth rotation and hook wear. If increasing the belt installation tension level does not prevent this type of failure, the drive structure may not be rigid enough to prevent deflection. Added structural support may be necessary to improve belt performance. If it is not practical to increase belt installation tension levels, increasing the sprocket diameters will allow higher drive loads to be transmitted with less belt tension.

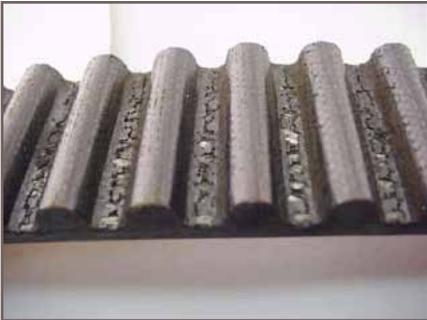
Figure 13 - Land disintegration

Curvilinear (HTD and GT) belts operating on sub-minimal sprocket diameters usually fail by land disintegration, illustrated in Figure 13, and tensile breaks. Trapezoidal (XL, L, H) belts will usually fail by tooth root cracks and tooth shear; however, tensile breaks are not uncommon.

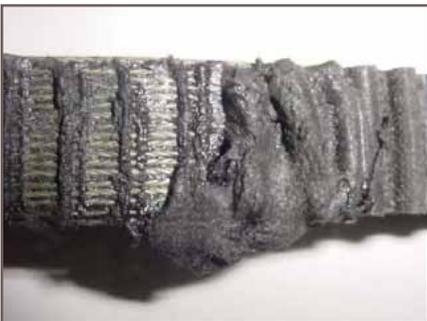
Figure 18 - Melting from high temperature operation, polyurethane

The body material used in urethane belts such as Poly Chain® GT® Carbon® belts is thermoplastic, meaning it has a melting point. When subjected to environmental temperatures in excess of 185°F, the teeth may begin to soften and deform. In addition, the tensile cord to urethane adhesion loses its integrity. Figure 18 illustrates a Poly Chain® GT®2

belt that was exposed to a high environmental temperature.

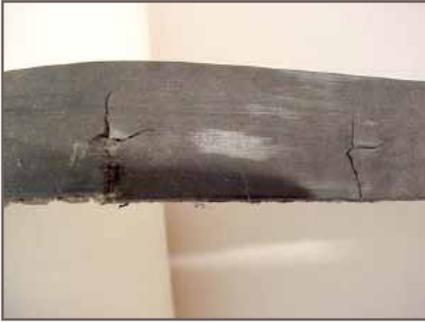
Figure 19 - Tensile cord failure from debris

The introduction of foreign objects between a belt and sprocket often damages both belt teeth and tensile cords. Tensile cords often fracture internally (see Figure 19) or fail later due to crimping, as shown in Figure 20. Once a portion of the tensile cords have fractured, the remaining tensile strength of the belt has been reduced considerably. This often results in a dramatic reduction in belt life. If belt damage from debris is noticeable, the belt should be replaced and the sprockets checked for damage. Damaged sprockets should also be replaced.

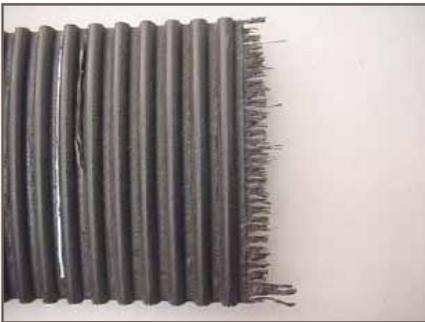
Figure 20 - Crimp failure due to debris
