Technical Service Bulletin

LOOSENING THE WATER PUMP BEFORE BELT INSTALLATION IS VITAL TO CORRECT TENSION ON HOLDEN & DAEWOO 16V PETROL ENGINES

Holden/Daewoo
Cielo, Espero, Kalos, Lacetti, Lanos, Nubira,
1.4 16V, 1.5 16V, 1.6 16V
Various engine codes

Gates Timing Belt & Component Kit Part Numbers: T310, TCK310, TCKWP310

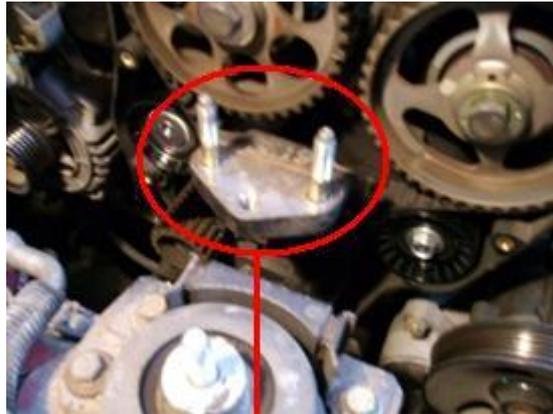
Fig. 4

In order to make access to the drive easier, it is recommended to remove the engine support (Fig. 4)

Engine support

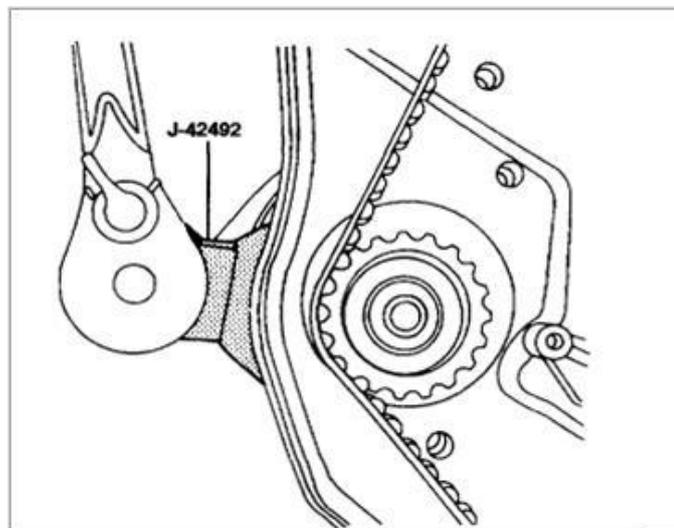
Fig. 5

1. Remove auxiliary belt crankshaft pulley, re-install bolt
2. Put engine at TDC: rotate the crankshaft clockwise until the timing mark on the crankshaft gear is aligned with the notch at the bottom of the rear timing belt cover, and align the timing marks on the camshaft gears (Fig 1). Ensure camshaft gears are locked.
3. Slightly loosen the bolts of the water pump
4. Rotate water pump anticlockwise, using special adjustment tool (Gates: GAT V501A or OE: J-42492 or KM-421-A), to release tension on the belt (Fig. 5)
5. Remove the timing belt, tensioner and idler.

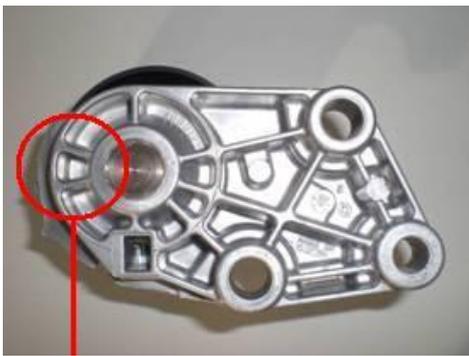
OE
Fig. 10

In addition, watch out for counterfeit tensioners which can be widespread in certain markets (Fig.10 and 11 are OE, Fig. 12 is counterfeit)
