## TECH NOTE

# INSTALLATION RECOMMENDATIONS FOR TIMING BELT SYSTEM ON HONDA 1.7L ENGINES

**BULLETIN:** TSB008\_AU

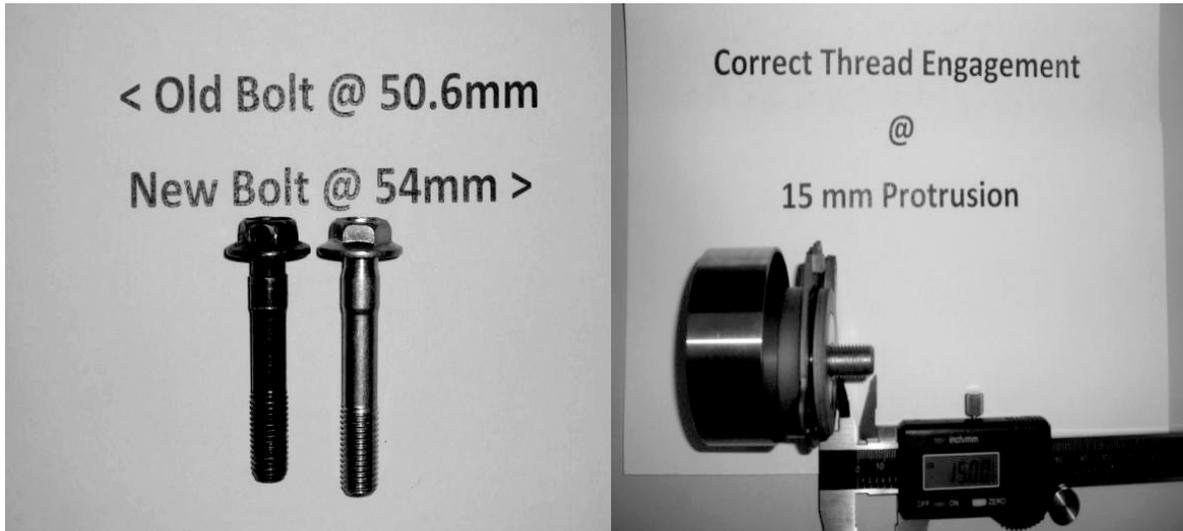
**PROPER INSTALLATION IS CRITICAL. IMPROPER INSTALLATION WILL VOID WARRANTY AND WILL MOST LIKELY RESULT IN MAJOR ENGINE DAMAGE!  
CRANKSHAFTS ON THESE ENGINES ROTATE COUNTERCLOCKWISE!!!**
