TENSIONER REMOVAL/ INSTALLATION PROCEDURE

SPECIAL INSTALLATION INSTRUCTIONS

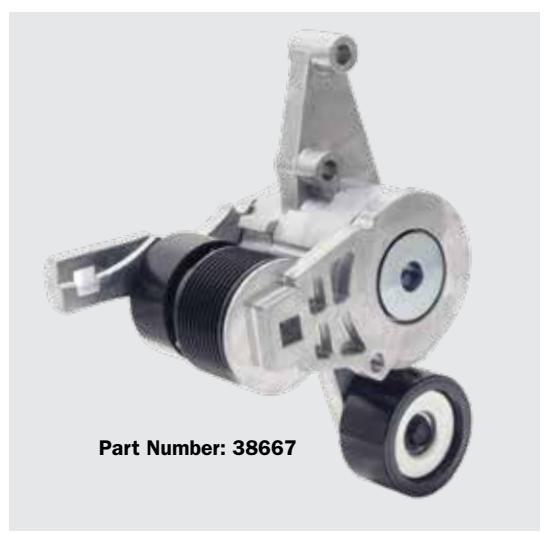
Install a 1/2" extension into the square hole on the grooved pulley (outer) arm.

Using a breaker bar, rotate the tensioner arm counter clockwise to release tension from the belt. Maximum allowable torque is 130 Nm (96 lb ft).

Insert the supplied M10 bolt or 10mm x 80mm pin into the feature on the arm to hold the tensioner while removing the fan drive belt.

Install the 1/2" extension/breaker bar in the square hole on the smooth pulley (inner) arm.

Rotate the arm counter clockwise to release tension on the accessory drive belt. Maximum allowable torque is 90-100 Nm (66-73 lb ft).

Insert the supplied M10 bolt or 10mm x 80mm pin into the feature on the body of the tensioner and on the arm to hold the tensioner in place.
