TECH NOTE

AUTOMOTIVE – ACCESSORY BELT DRIVE SYSTEM

BULLETIN: TSB024_AU

INSTALLATION INSTRUCTIONS FOR BELT OAP7144

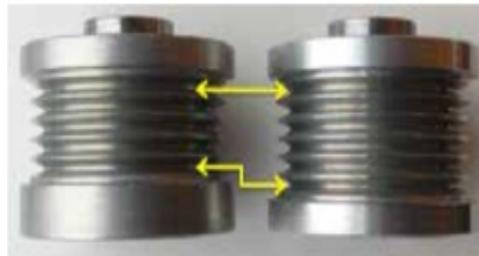
Fig. 1

On certain Opel/Vauxhall/ Holden engines (codes: A14NEL, A14NET, A14XEL, A14XER) the belts may have 5 or 6 ribs while the pulleys may have 5 or 6 grooves, depending on the manufacturing date of the car. Gates recommends replacement of a 5 groove OAP (Fig.1 left side) with the 6-grooved OAP7144 (Fig. 1 right side).

If a belt with 5 ribs must be installed onto OAP7144 (Fig. 2), the outer groove (away from the engine) must be left open.

If the belt is not placed correctly on the OAP like this, severe misalignment occurs, which may cause premature failure. Fig.3 shows an OAP with 5 grooves that must be replaced by the 6-grooved OAP7144.
