TECH NOTE

AUDI & VOLKSWAGEN SERVICE INFORMATION

BULLETIN: TSB009_AU

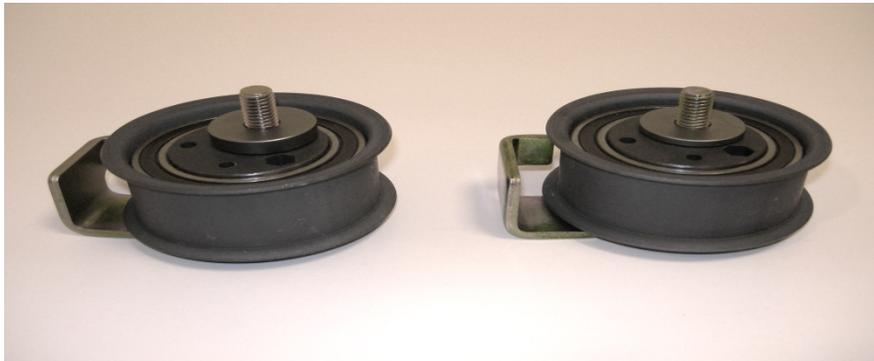
OE 058109243D

Gates - T43065

(included in Gates - TCKH317A Kit)

Note the size of spacer is 6mm

Gates - T43123

Note size of spacer 3 mm

Always double check the component you are removing. You may encounter a difference in spacer thickness of the tensioner pulley. If the spacer currently on the vehicle is 3mm, then it will need to be obtained from the OE. If the spacer is 6mm it will be supplied in the Gates TCKH317A. This will guarantee proper system alignment.
